Manhole Inspection Summary

Manhole # S37A__022MH

Record Plat: **37A** Node: **022** Status: **Found**

Location Address: **constitution st**

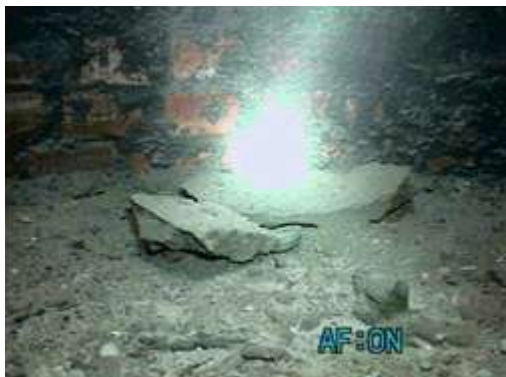
Defect 3

Condition: ☐ Sound ☐ Cracked ☐ Root Intrusion ☐ Deteriorated ☐ Leaks ☒ **Debris**

channel debris

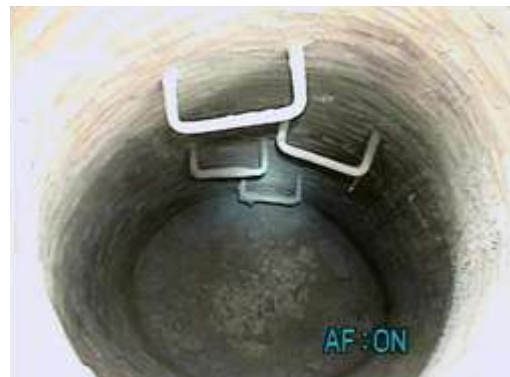
Defect 2

Count: **4** Missing: **0** ☒ **Corroded**

steps

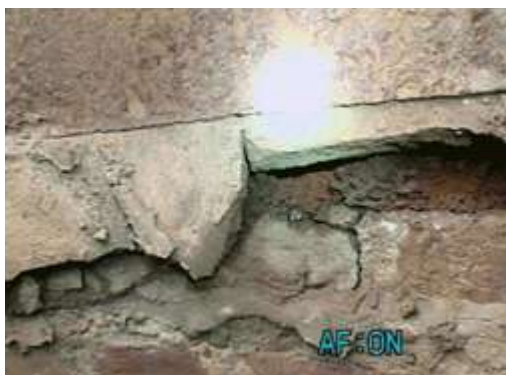
Defect 1

Condition: ☐ Sound ☒ **Cracked** ☐ Root Intrusion ☒ **Loose Brick** ☒ **Deteriorated**

cracked, deteriorating chimney. loose bricks. frame adj

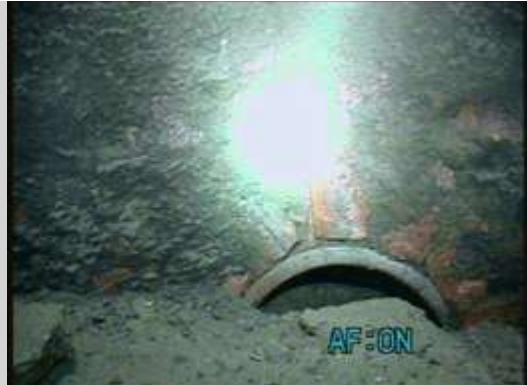
12 O'Clock Outflow

Deposits: ☐ None ☐ Mud ☐ Sludge ☒ **Debris** ☐ Grease

Silt Depth: 0 (in.) Deposits Extent: **Heavy**
